The Day After: Recovery Efforts at St. John's Mercy Joplin

Steve Bollin, Regional VP, Mercy East Community

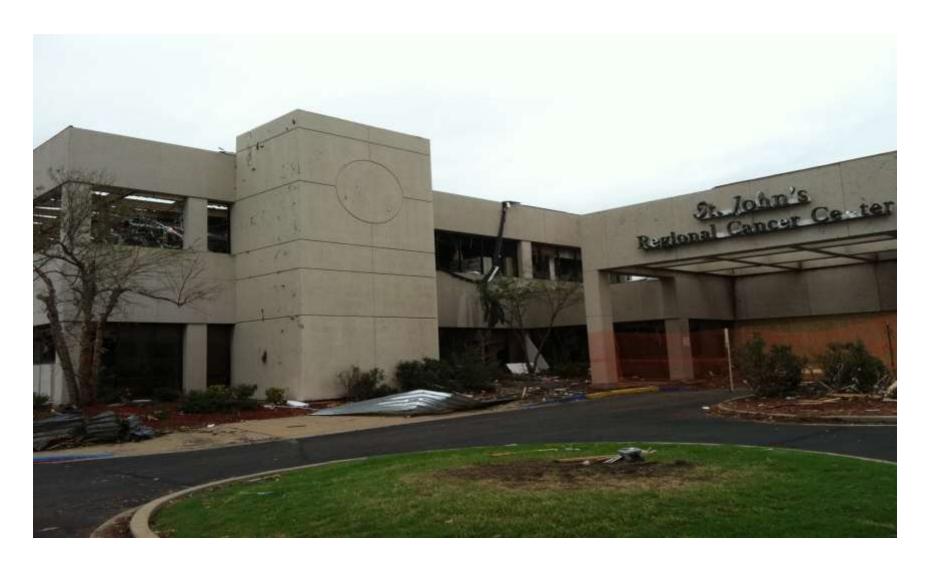
- Structure remained standing, but with major damage
- Nearly all windows and doors were broken
- Entry to building completely unsecured
- Large amounts of debris remained
- Downed power lines around the perimeter
- Damaged vehicles posed significant obstacle
- Roofs of buildings were peeled away

Unsecured Entrances

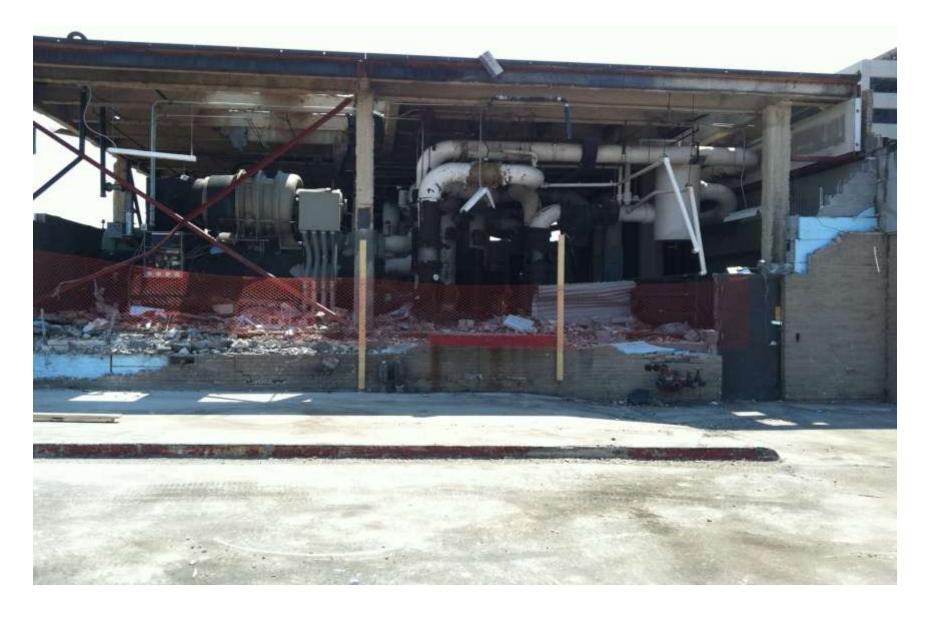
Unsecured Buildings

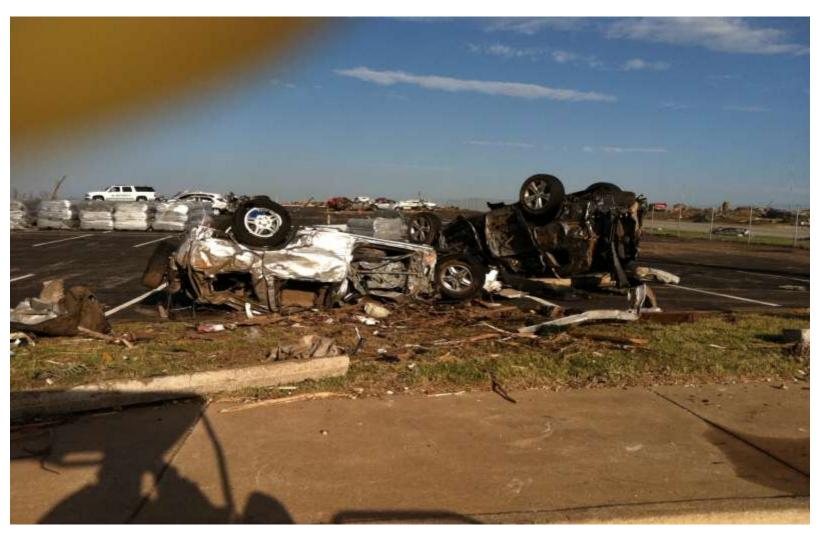
Vehicles Destroyed

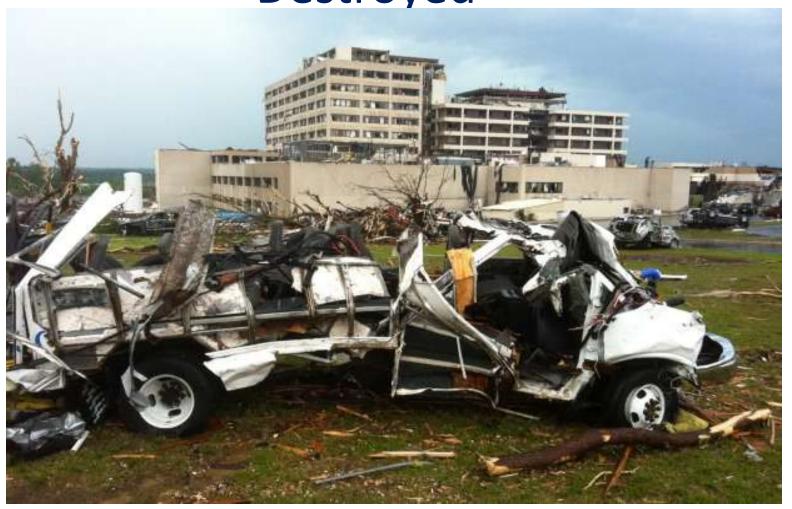
Two week-old Hospital Shuttle Destroyed

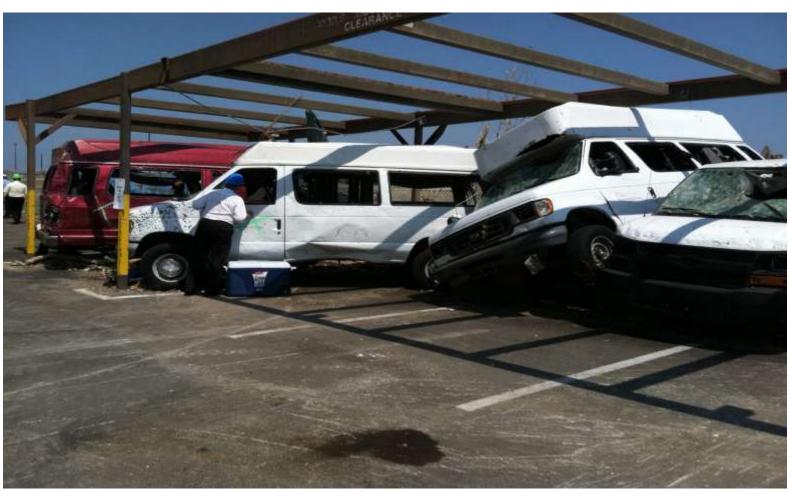
Other Hospital shuttles moderately to severely damaged

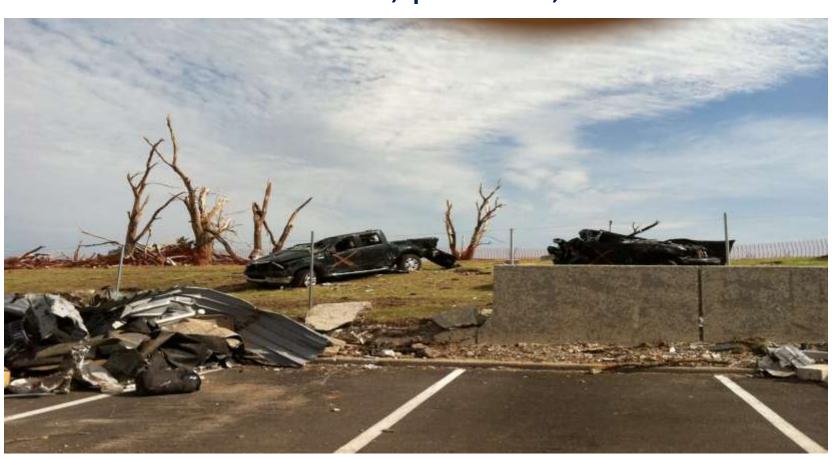
Not all vehicles left behind belonged to St. John's coworkers, patients, or visitors

- Roughly 250 vehicles remained on site after storm
- All vehicles parked on site received at least moderate damage; some vehicles were piled several high up on top of each other and against the building
- Oil, gasoline, antifreeze, other chemicals were leaking out of damaged vehicles

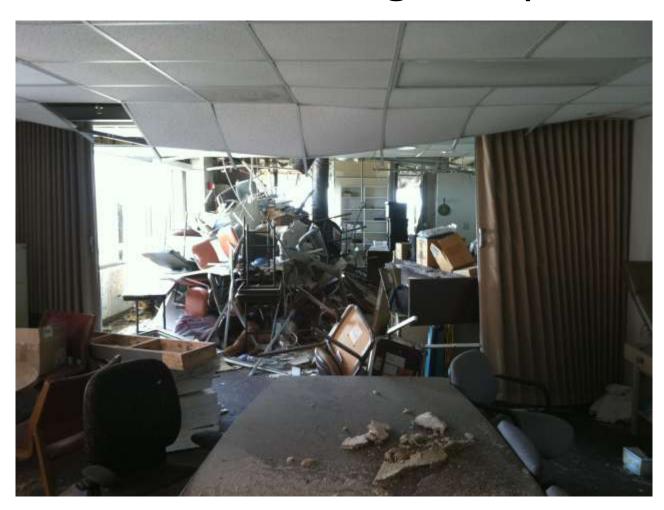
- Building infrastructure shifted at some points
- Concrete floors were reported by coworkers to have moved vertically during the tornado
- Contents of sanitary pipes sucked out and blown throughout building
- Walls collapsed throughout, blocking routes of evacuation

Interior Damage Walls and Ceiling collapsed

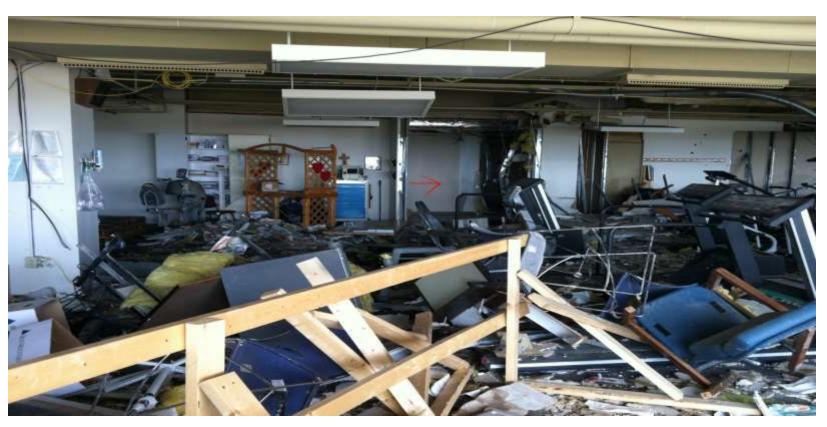
Debris strewn about hallways and rooms, including equipment and furniture

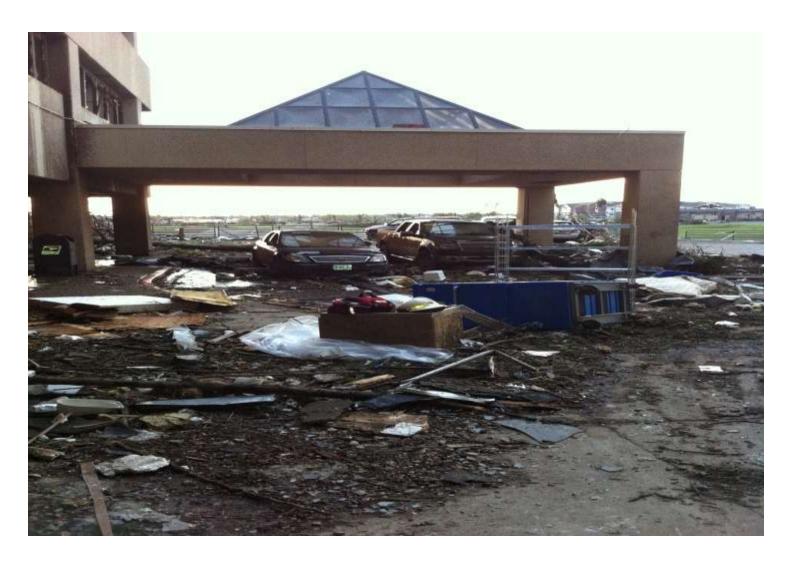
Debris at the Main Entrance

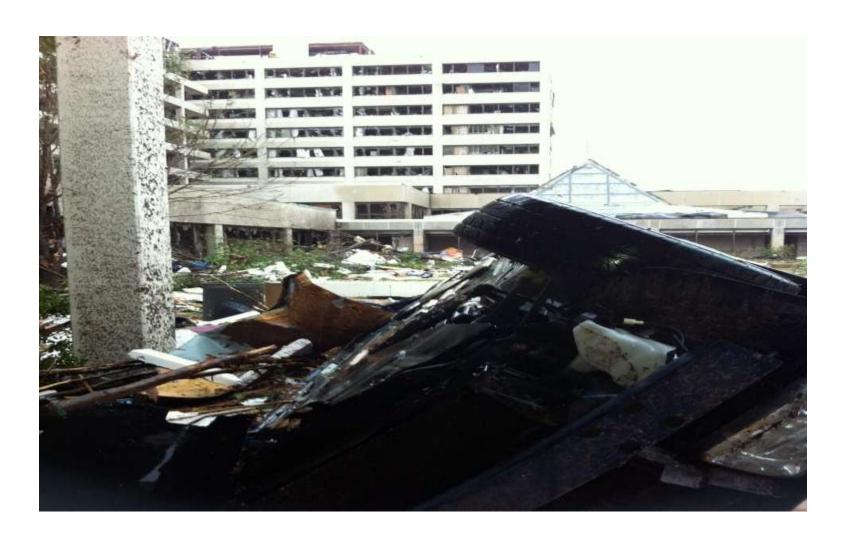
Vehicle near Cancer Center Entrance

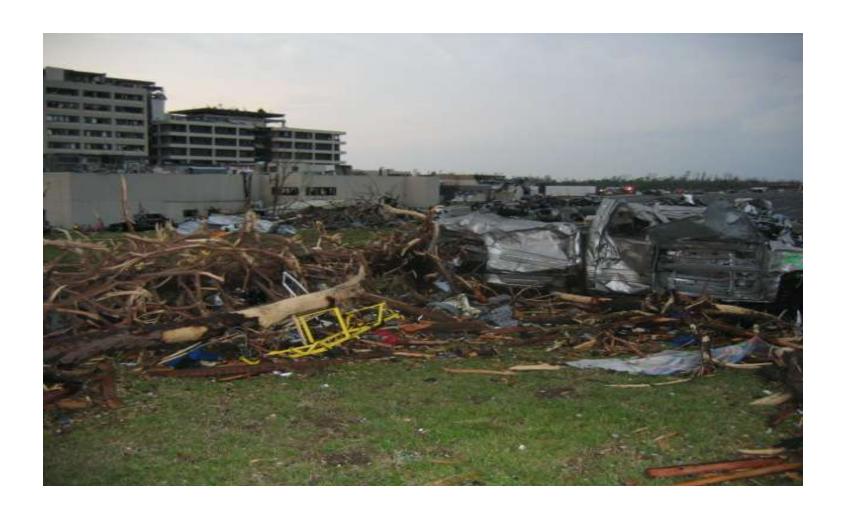
Debris Piles

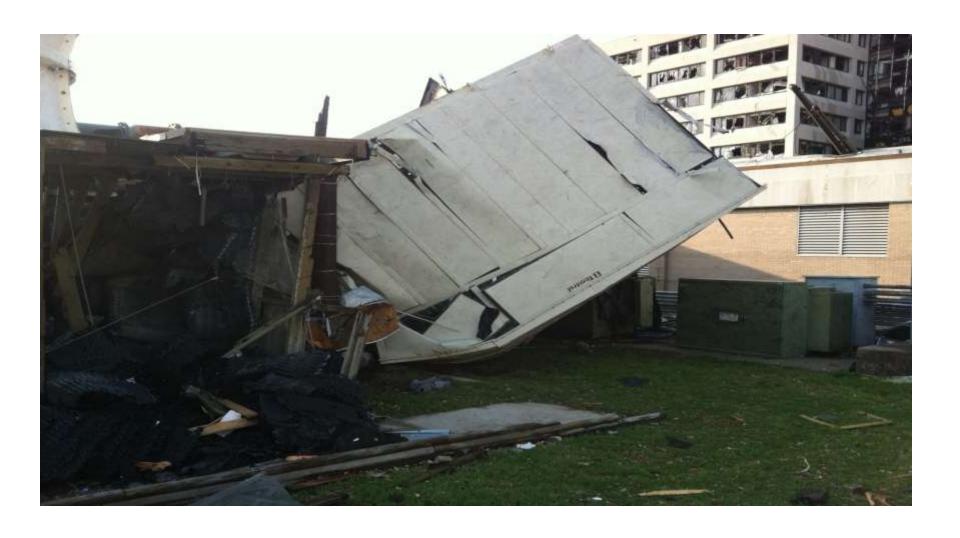
- Multiple items became projectiles rocks, furniture, branches, vehicles, chillers
- Baseball thrown at 90 mph has the potential for doing damage
- Projectiles moving at 200 mph can cause catastrophic damage

7 Ton Projectile

- Disaster planning needs to be revised to consider the effect of projectiles, especially where people are taking cover
- Evaluate where items are stored for example, storing excess construction and building repair supplies in storage space on top of a building
- Consider using high-strength shatter-resistant windows
